CASE: Boiler Lost at Sea

- All Motors Stopped due to Excessive Amount of Salt Water in the Diesel

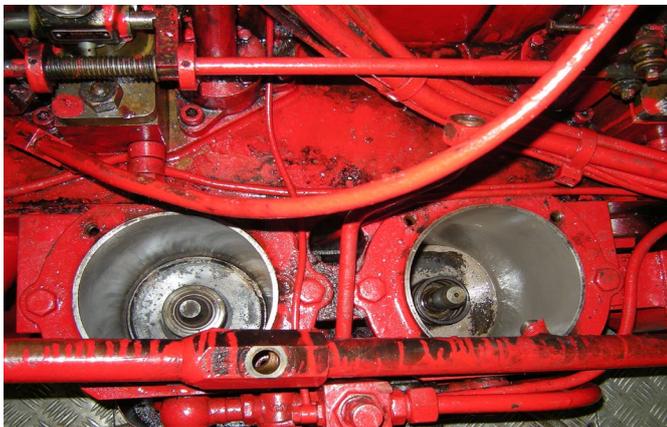
It turned out the diesel motor contained too much water: Normally water condensate drains off via valves. In this case, the amount of water caused the crew repeatedly to change filters to the degree where no more filters were available in high seas. - Sailing without filters destroy nozzles.

▲ *Filterhouse Demounted for Cleaning*

All tanks were drained off at the same time: Four bottom tanks, four settling tanks, and two daily tanks inclusive related nozzles, pumps, and pipes. The latter replaced, and the tanks mechanically cleaned followed by a steam cleaning. Details, as making sure of absolutely dryness in all corners, ensure a high quality work. After refilling of diesel, a biocide treatment started.

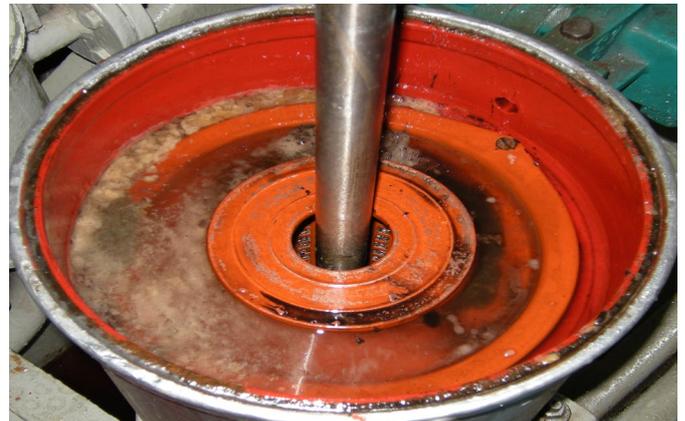
The amount of water was not only due to freshwater condensate. Volumes of seawater had gained access to the bottom tanks. The mixture of salty water environment and diesel provided an excellent growth media for bacteria, spreading diesel pest to the system of settling tanks, nozzles, and day tanks: The diesel plague area escalated disproportionately.

▲ *Bacterial Growth in the Filter House*

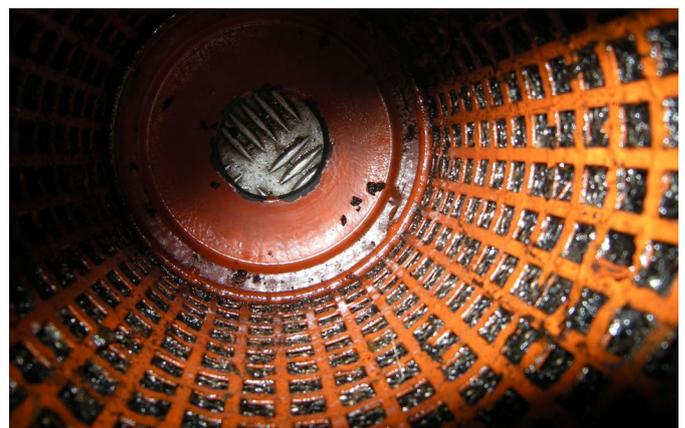
▲ *Inner Core of a Poluted Filter*
