CASE: Ocean Teams Chemical Cleaning and Passivation

- resulted in huge savings for our customer

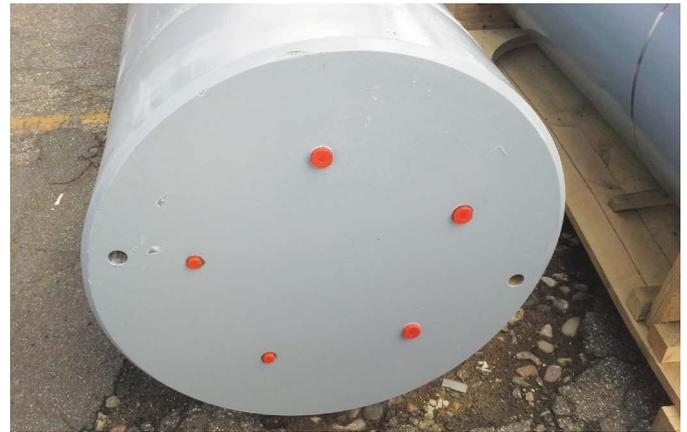
▲ *Incorrect sealing of the bottles by using the wrong vents and seals enabled saltwater and moisture to penetrate and thereby cause the rust.*

However, prior to the process of using these bottles, they found out, that they had stored the bottles incorrectly, and therefor rust was showing on the inside.

Ocean Team created the right mixture of chemistry to clean the bottles from rust deposits. They filled every bottle with this chemistry and left them to soak for 12 hours.

After the chemical cleaning process had ended, the bottles went through a new video inspection and approval by the customer. Afterwards, the bottles were nitrogen dried and passivated. Finally, the customer tightened the reduction vents securely to make sure the problem would not arise. The entire process lasted only 3 days. The following day, the customer attached the nitrogen bottles to the ship.

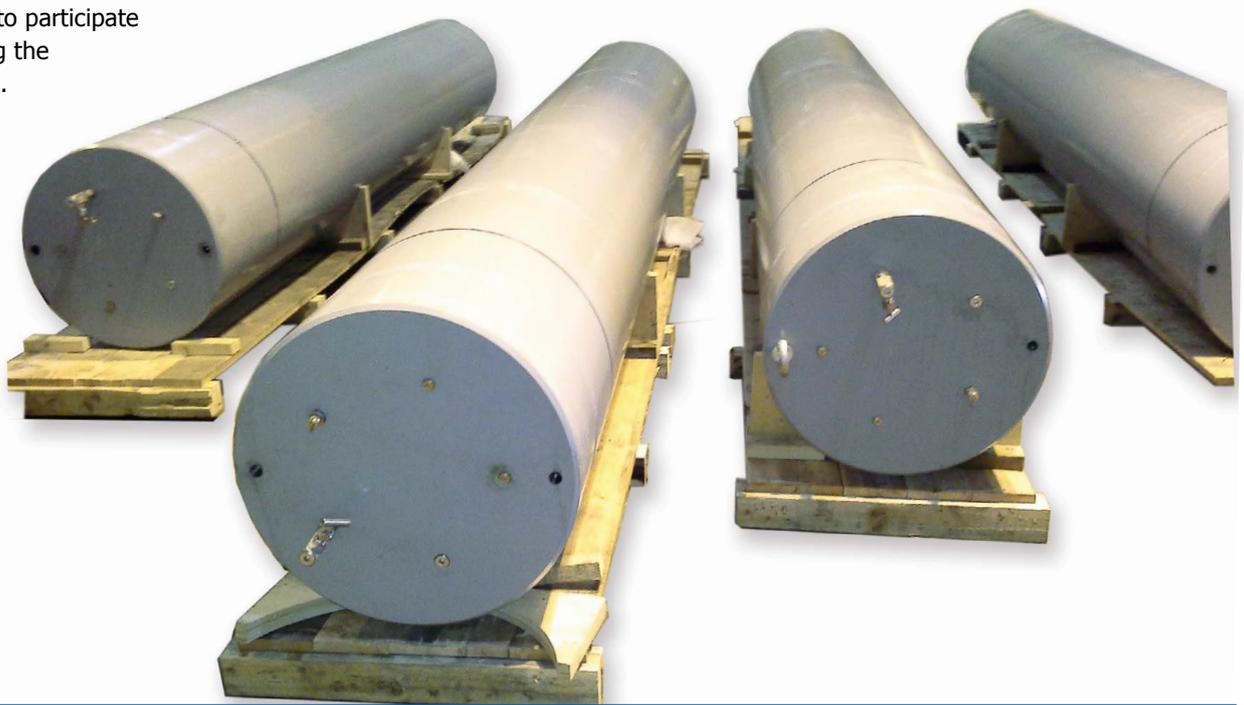
After an in-depth video inspection of inside of the nitrogen bottles, it was fair to say that they did contain rust deposits. They had to remove the rust before using the bottles, as it potentially could affect the control valves negatively.

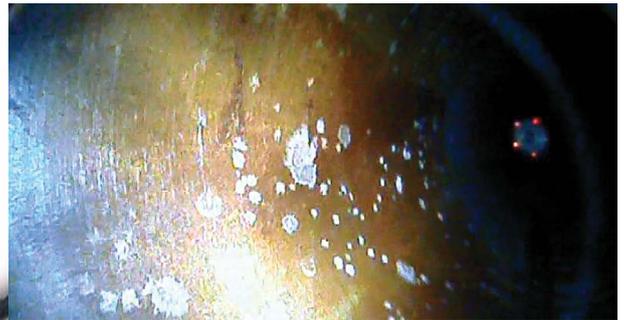
Photos above clearly show the badly infected nitrogen bottles.
Photos below shows the bottles after chemical cleaning.
Now ready for passivation. ▼
