**CASE:**

**How Dependent is One of a Functional Toiletsystem?**

**Ocean Team's Solution: Installation of a new system.**

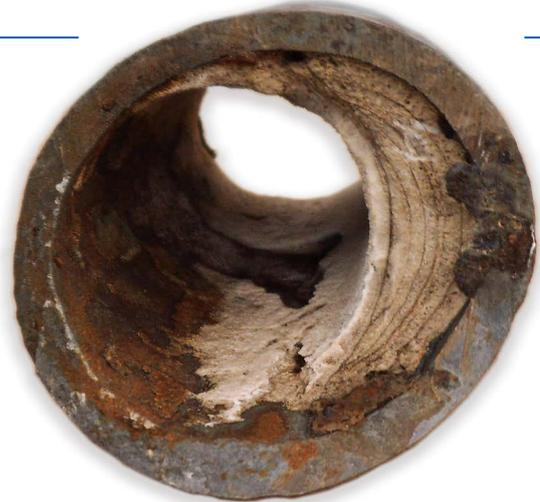
As Ocean Team penetrated the pipes with a video inspection, it revealed a very thick inner coating. Samples were picked out in order to find its origin. By a closer sample review it indicated a huge amount of layered uric acid stones.

▲ Uric acid stones and other growth lie layer upon layer - almost similar to growth rings of a tree. The passage keeps decreasing.

It was difficult to conclude on other infecting particles, so samples were tested with chemistry, yet, no chemistry was able to dissolve the stone. Due to this this and because of the badly shaped pipes, they commonly decided to skip both the chemical- and mechanical cleaning. Ocean Team suggested to remove and deposit the wast toilet system and a following installation of a new pipe system. This time using pipes with a greater diameter.

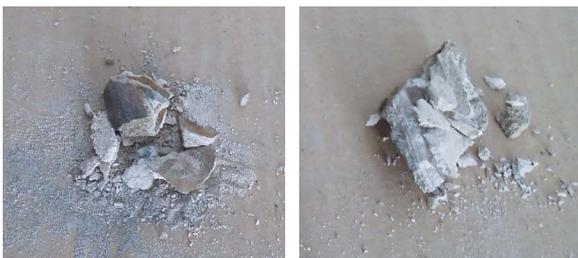
▶ Samples were send to the Institute of Technology for analysis with following chemistry testing. No chemistry was able to break down the stones.

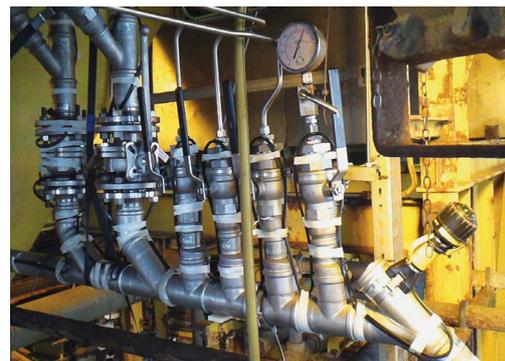
◀ The newly installed pipe system. In order to avoid frost skips, they dressed the pipes in heating cables.

Ocean Team spend only two months on changing the system to a new with a wider diameter. This change reduced the suction pressure significantly as well as it reduced the wear on the toilet house. Now, the customer only needed one vacuum pump switched on periodically. Ocean Team rebuild the toilet system while the old system was still up and running.
