Iceblasting of 260 Centrifugal Separator Dishes

- Ultra clean surface means everything performing ceramic coating

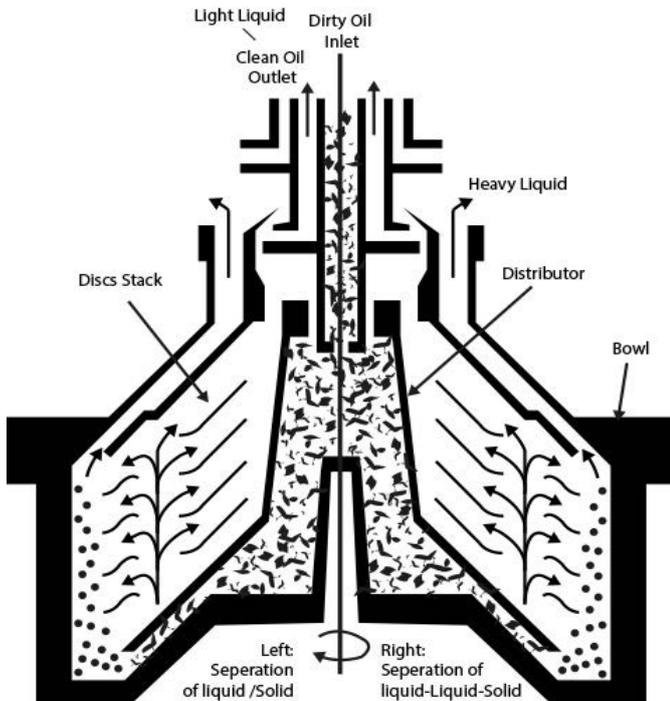
▲ Separator - The dirty oil moves downwards towards the separator and back up through the dish holes and can easily stick to all surfaces.

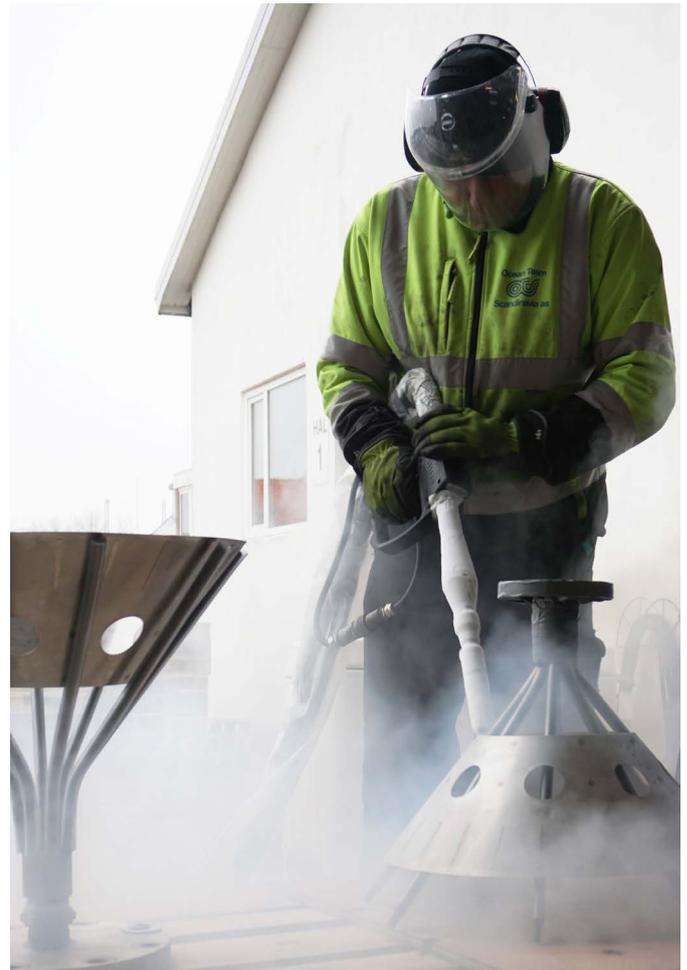
▲ Iceblasting at the OTG workshop

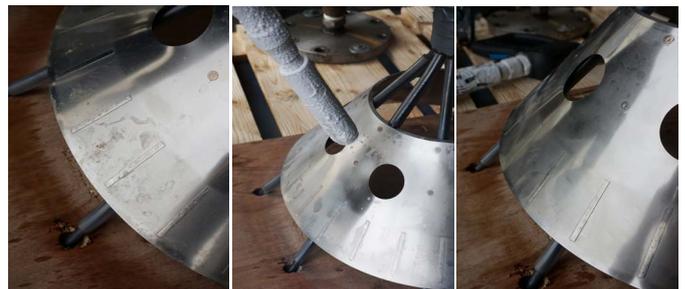
▲ *Stuck and burned oil and dirt prevent ceramic coating. These visuals show one of the centrifugal dishes prior to, during and after iceblasting.*

The iceblasting method does not affect the environment nor does it damage the dish's surface. Dry ice is carbon dioxide in solid form, produced by expanding fluid CO₂. Purifying using this method is very efficient and as the equipment never touches the product, damages as wear and scratches are avoided.

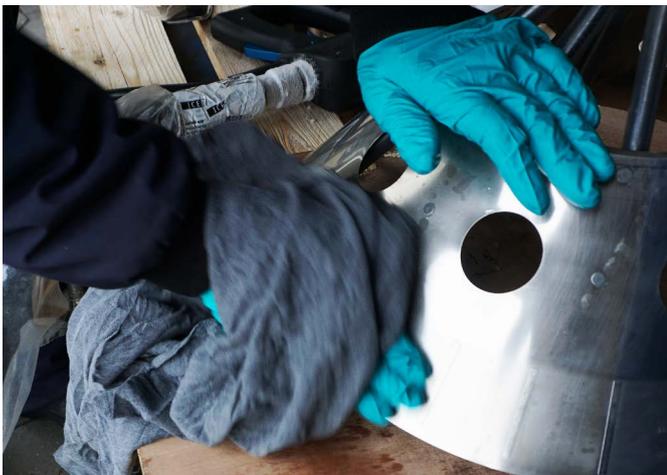
▲ *Last part of the process - drying off thin film.*

Each dish is cleaned time efficiently. Ocean Team ended up with a visual cleanliness exceeding expectations, but when performing a cleanliness test it indicated a thin film created by the extreme low temperatures from iceblasting. Even though the dish was clean to the eye, it was important to dry off the surface in order to reach the ultimate desired effect. Ocean Team Group returned the cleaned dishes for ceramic coating. As the newly coated dishes reentered in to production, they enabled a faster production pace, less repair expenses and, nonetheless, increased production efficiency.

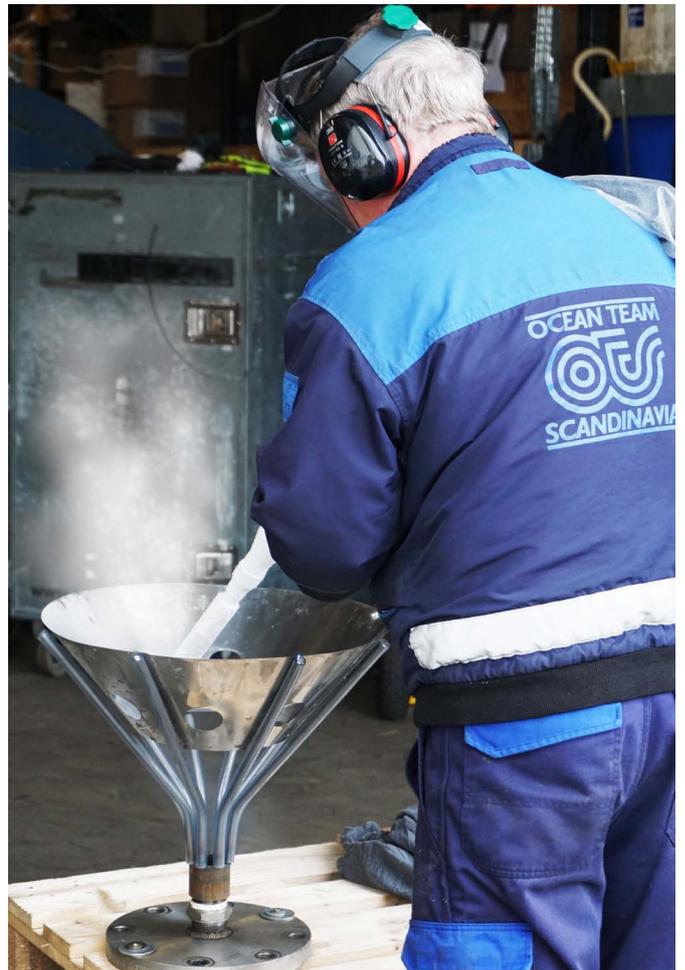
▲ *The iceblasting work process*
