CASE: Mechanical Cleaning of Offshore Heat Exchanger

- With an Innovative, Cost Effective Twist

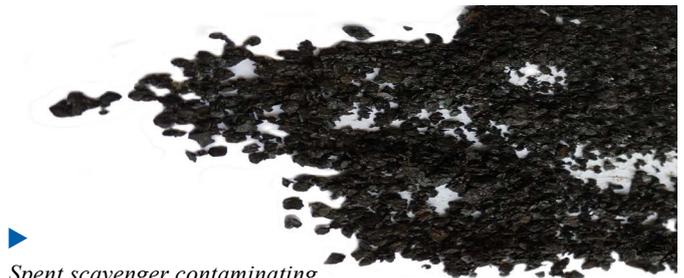
▶ Spent scavenger contaminating particles caught in the filter.

The heat exchange holds mercury that carries with the cleaning water, when high-pressure cleaning. Ocean Team found a solution to filtrate the produced water into one tank only and from here re-use it over and over again. This way, the customer saved costs on water use, while the amount of mercury contaminated water sent to waste deposit became significantly reduced.

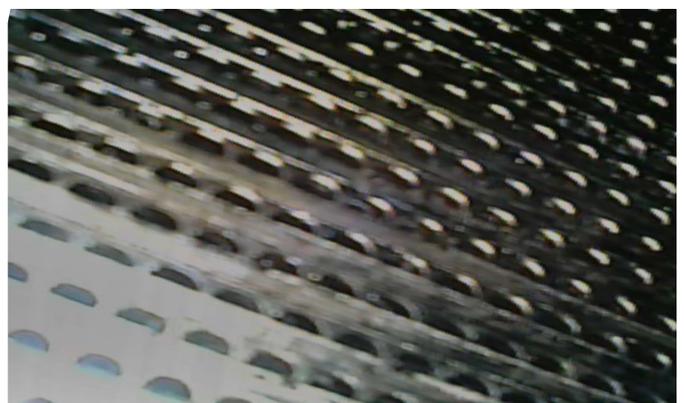
▲ The visual shows the printed circuit after mechanical cleaning.

Ocean Team obtained the pressure bar of the customer's desired outcome, shortly, within their maintenance shut down period. With a result of only 0.62 bar differential pressure (fig.2), they created a spent scavenger free passage through the printed circuit and the heat exchanger was again ready for production.

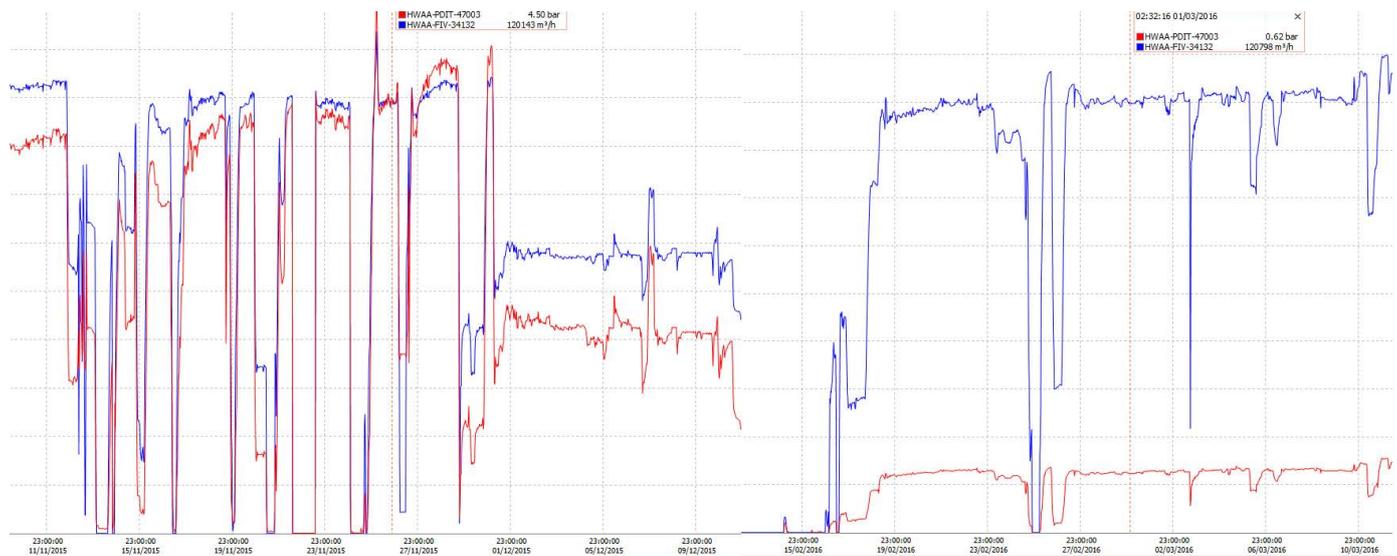
Before the mechanical cleaning, the differential pressure in the heat exchanger showed an alarming 4,5 bar. Figures 1 and 2 provide visuals on the heat exchanger performance before and after Ocean Team's mechanical cleaning. A level between 0,3 - 0,6 bar is considered free passage inside the printed circuit.

▲ Fig. 1. Before mechanical cleaning - diff. pressure = 4.5 bar.

▲ Fig. 2 After mechanical cleaning - diff. pressure = 0.62 bar.
