CASE:

Approx. 50% Savings with Chemical Cleaning

An effective and innovative solution which had never been tried before!

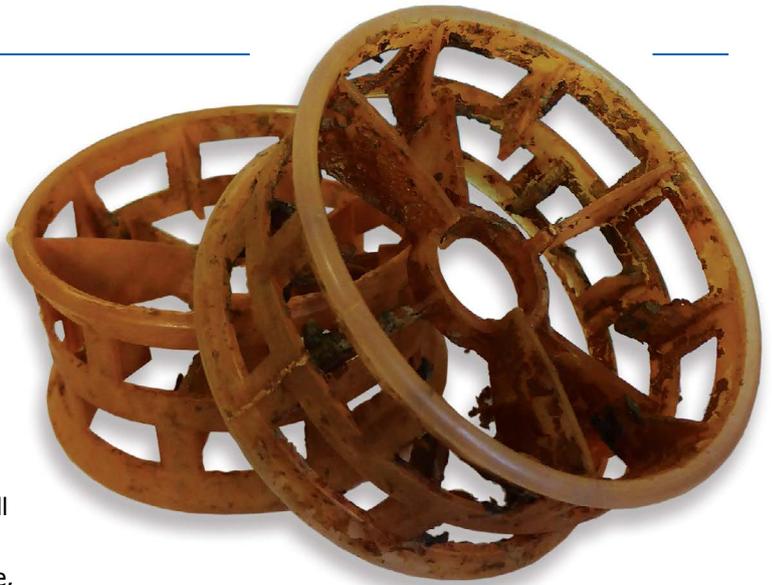
▲ *"Tower Packing Rings" before undergoing their chemical cleaning. It is clear to see how dirty the rings are, as well as the number of nooks and crannies, where oxygen bubbles and other issues may form, meaning filtering is reduced.*

The solution was to rent two cement mixer trucks. All tower packing rings and chemicals were poured into mixer, which then served as a giant washing machine. When the rings were decontaminated, they were poured out of the cement mixer on a chute. Here three garden sprinklers rinsed the rings clean of chemicals. It was a success and the rings were 100% decontaminated and could be reused.

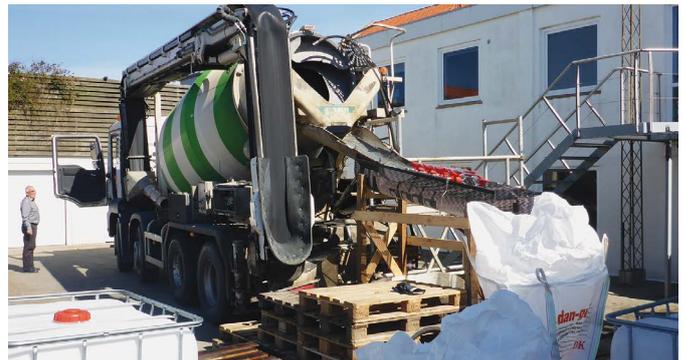
▲ The cement mixer was used as a "washing machine".

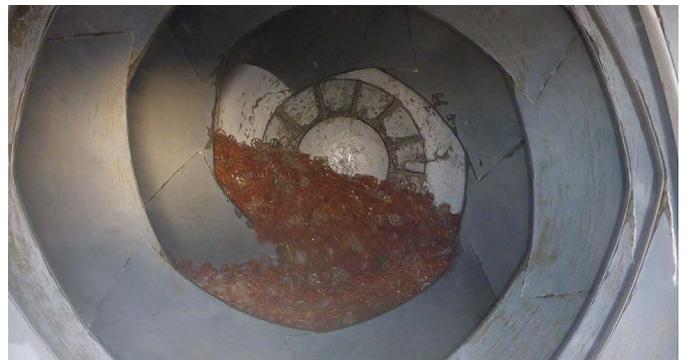
▲ "Tower Packing Rings" being chemically cleaned inside the cement mixer.

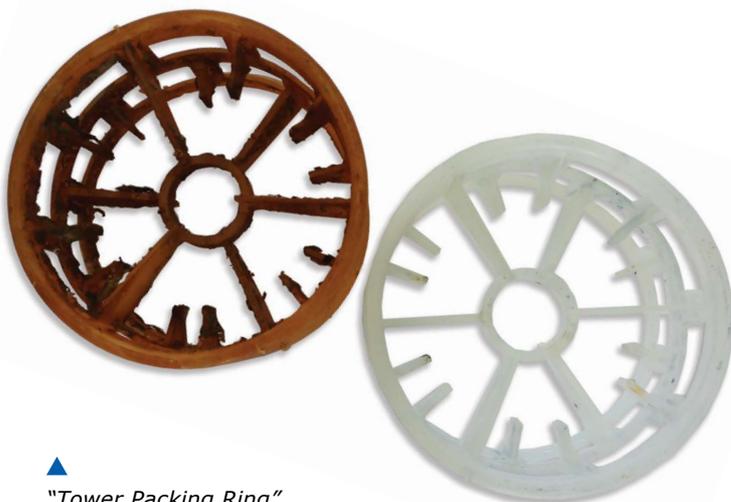
▲ "Tower Packing Ring"
Before and after chemical cleaning.

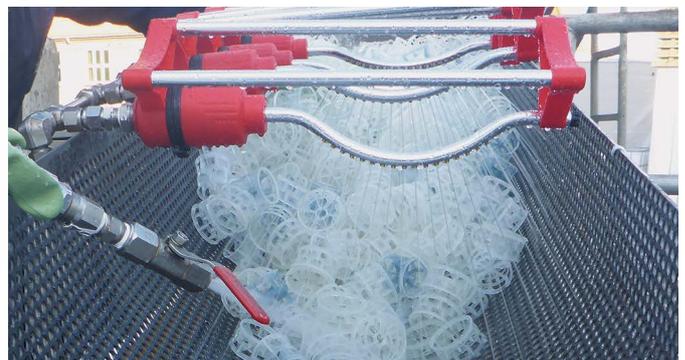
▲ The chemically cleaned "Tower Packing Rings" are rinsed from chemicals by three garden sprinklers.
